Aircraft Accident Brief

**EgyptAir Flight 990
Boeing 767-366ER, SU-GAP
60 Miles South of Nantucket, Massachusetts
October 31, 1999**

**NTSB/AAB-02/01
PB2002-910401
Adopted March 13, 2002**

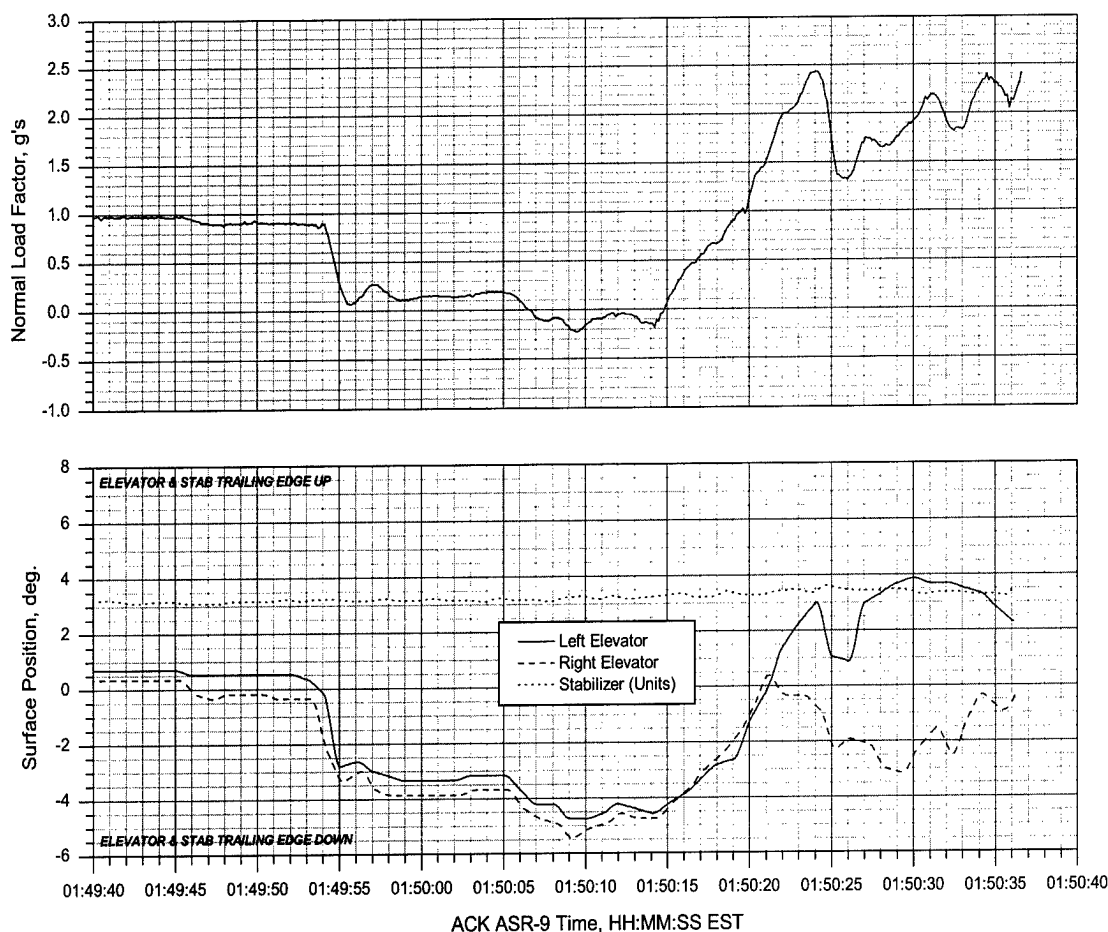
Figure 4. Graphs depicting the accident airplane's normal load factor response to elevator and stabilizer movement.
